A complex reinforced structure applied at hilly road repair case in Taiwan

Specification : ACEGrid® GG400-I,GG200-I
Quantity : 12,000m²
Owner : Pingtung County Government
Designer : Bi Shan Consulting Engineering Company
Contractor : YongXingCheng Construction Company

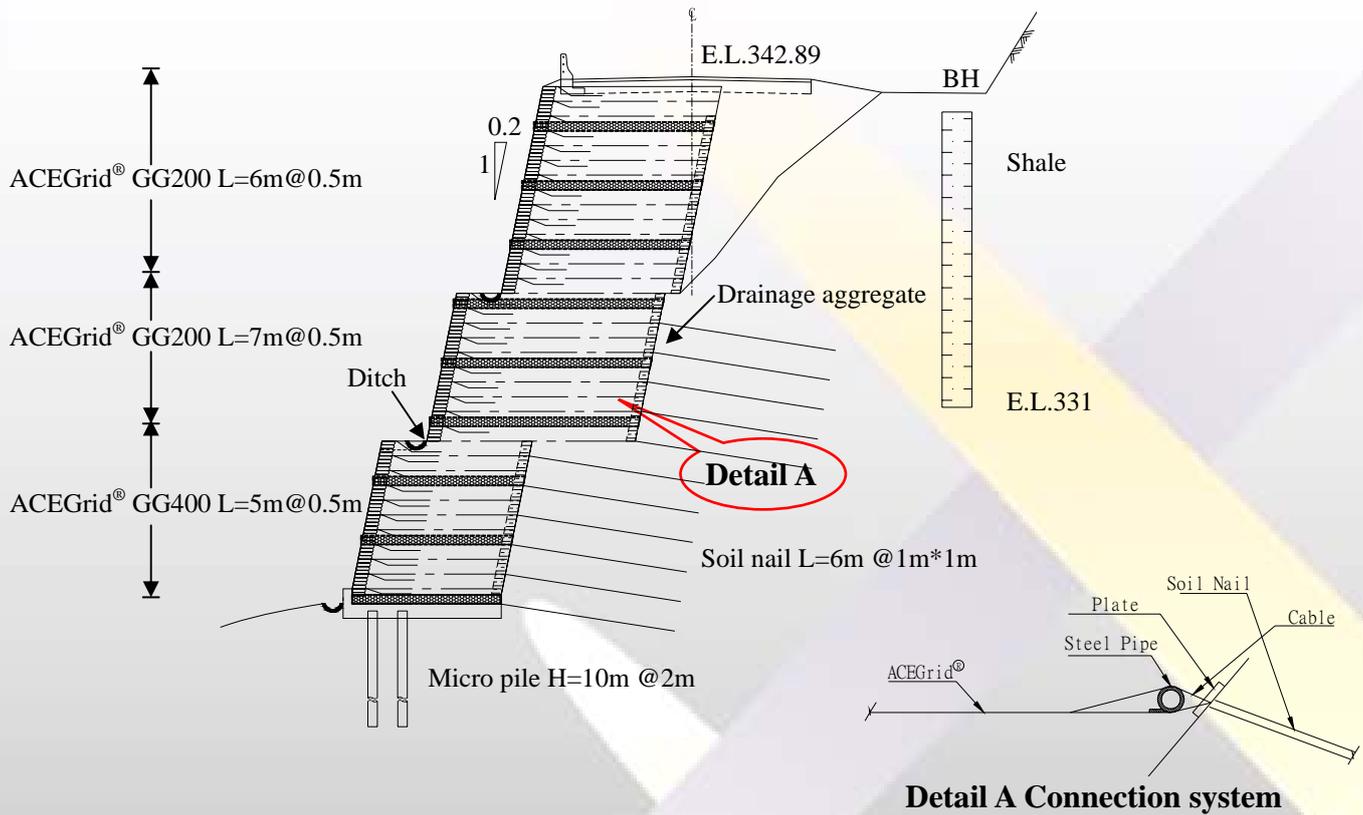
Figure 1. Cross section of design drawing

In view of the fact that short buried distance for geogrid might cause a structural failure, one simple but wise connection system was invented to competently correct the problem. Please refer to Detail A Connection system in Figure 1, the notion of the connection system is to guide the stress of geogrid perpendicular to the forwarding direction of the route. Steel pipe attaches to the reinforced plate of soil nail through galvanized steel wire strand. Thus, once the geogrid goes around the steel pipe and gets fixed on the ground by anchor bars, the mechanics is completed. All steel components of the connection system should be galvanized as to reach the corrosion protection.

The reinforcement construction began from the bottom of destroyed slope and completed the reinforcement of lower layer before next higher layer was established. When the expected height was reached, soil nails should be served by drilling machine. (see Figure 1)

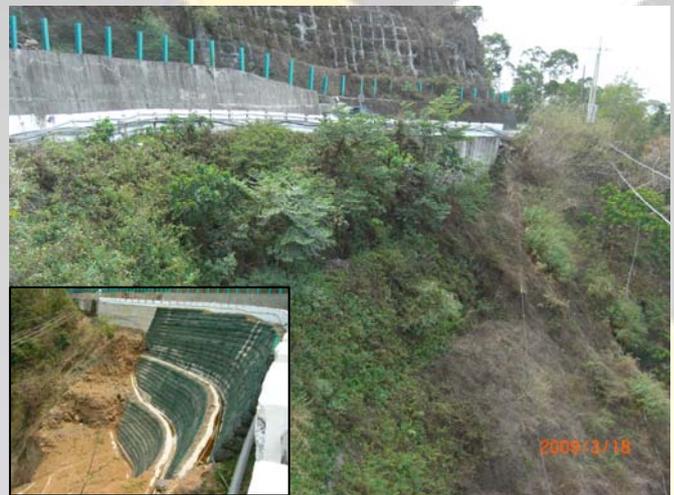
Figure 4. After construction

As a result of lying in the Circum-Pacific seismic belt and the tropical marine zone, Taiwan comes with fragmental geology and succumbs to attacks of server tropical storms. Under such circumstances, after storms or torrential rain, road collapse problems in mountainous areas are occurred frequently. Apart from the restoration itself, what people concern is the protection of the nature. Through the complex reinforced construction method, bad access problems for cramped site could be overcome; simultaneously a safe and economic structure is created appropriately to maintain the residents the safety by lessening environmental impact during construction. County Highway 35 (5K+000), Majia Township, Pingtung County on the steady structure still plays a significant role for traffic after serious storm attacks during past two years.
