Case study of using complex reinforced structure to repair mountain road landslide in Taiwan

Case description

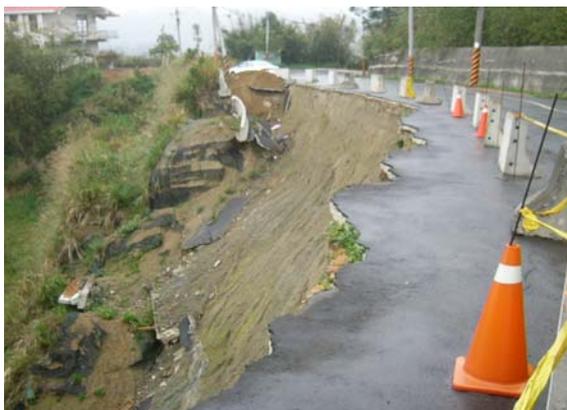
It is for Baoshan township in Hsinchu County, the down slope of a road. It was collapsed after Typhoon Nari swept and was repaired by reinforced structure in 2001. In 2004, it was completely disrupted during a typhoon caused by continuous torrential rain. The scope of destruction was about 70m wide, 10m long and 19m deep. The collapses dropped to the adjacent valley about 50m in depth. The collapsed interface was steep, and looked like planar sliding damage (Figure 1). The main reasons of the damage can be divided into natural factors and human factors. The natural factors were due to the successive heavy rainfall of up to 200mm/day. A large number of water infiltrated into the structure and stayed in it causing the soil shear strength greatly reduced. The human factors were, judged by the observation of the scene, the reinforced material were placed only 0.5 to 0.6H. The above factors were the main cause of the damage.

Figure 1. Steep collapsed interface like planar sliding damage

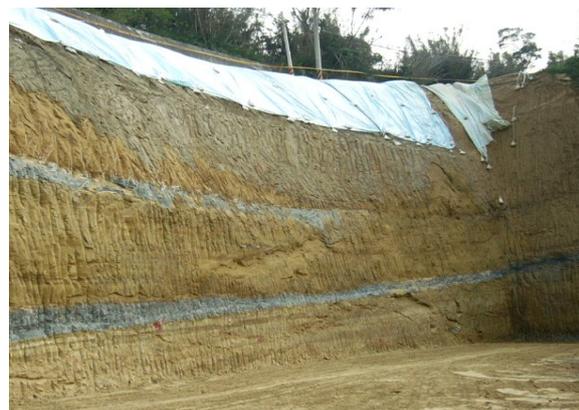
According to the exposed surface, the geological condition in this case can be obviously observed that the stratigraphic distribution from the top to down was roughly divided into : (1) Topsoil layer: yellow brown silty sand and with a trace of clay, SM soil classification to a thickness of about 3 ~ 5m; (2) Rock layer : a highly weathered brown yellow sandstone, content of plant fossil, small particles, bad cement, poor bedding and joints or developed, the thickness of about 10 ~ 15m. The layers in the depth of about 10m and 15m respectively nearly parallel, about 10 to 60cm thick gray brown mudstone, the position about N70°E/15°NW and crossed with the bare structure (Figure 2).

Figure 2. Geology structure of exposed collapsed interface

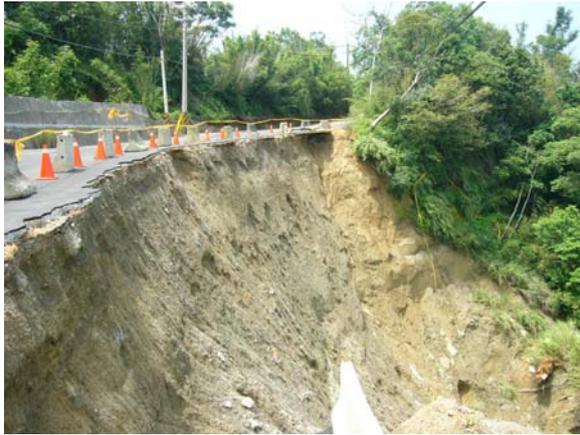
Figure 4. before construction

The failure type in this case is overall collapse occurred in the interface between the reinforced and original strata. Such failure mode exists commonly among the mountain road widening engineering and retaining structures in excavation areas. And to repair such damage, using complex reinforced structures can reduce the traffic impact fast and effectively. The photographs before and after construction are as figure 4&5 below.

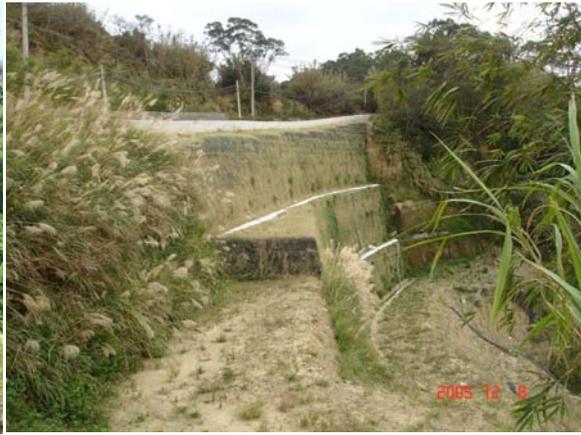
Figure 5. after construction

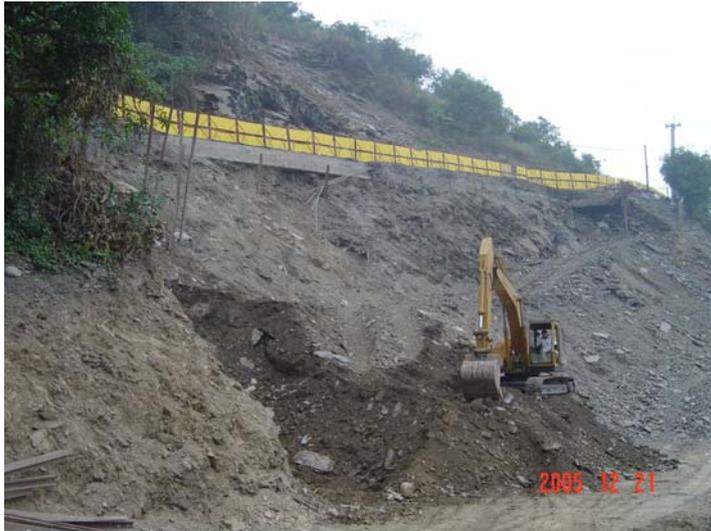
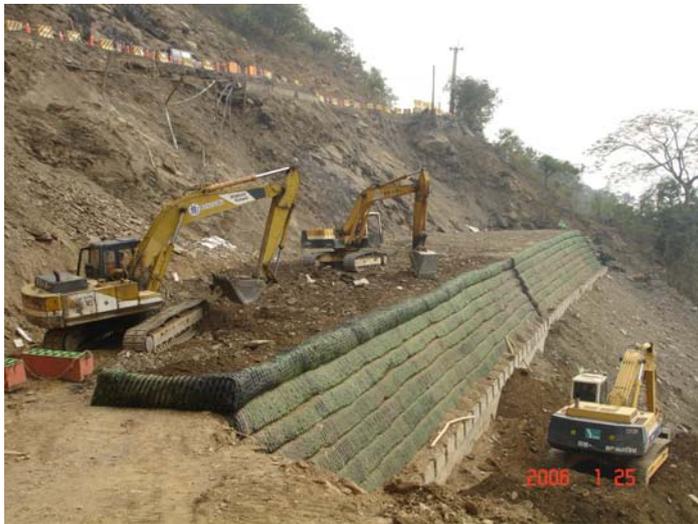
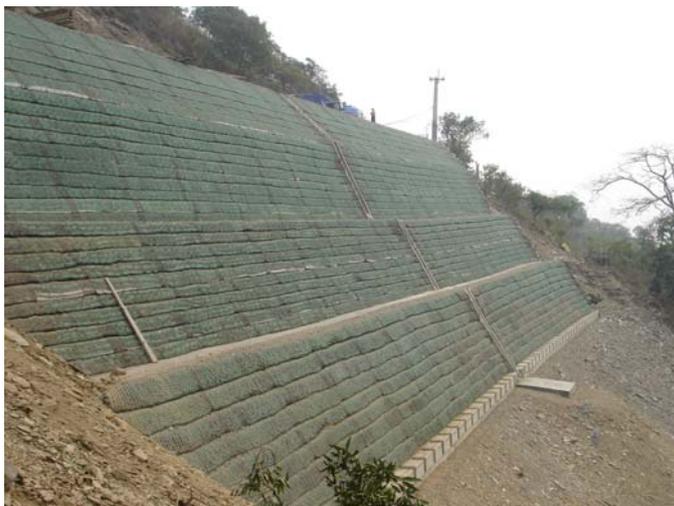
The design section of reinforced retaining wall is shown in figure 6. The situation before, during and after the construction is shown in Figure 7. Till now, nearly a year after the construction, the reinforced retaining wall remained stable overall except the slight subsidence on the top of it.

(a) Before construction

(b) During construction

(c) After construction

Figure 7. Before, during and after construction
